# **Existing Conditions Report**

## **Griffin Old City Hall**

### **Griffin, GA**

**June, 2015**

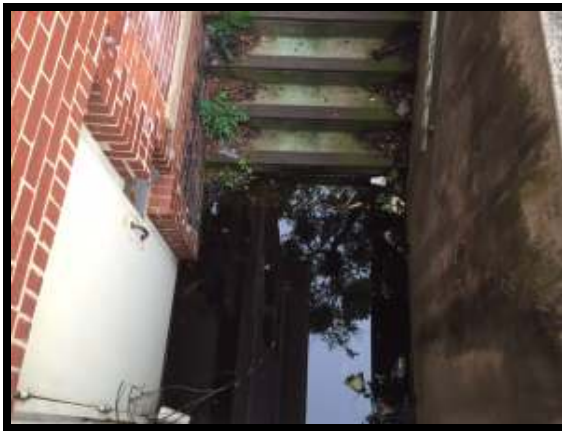
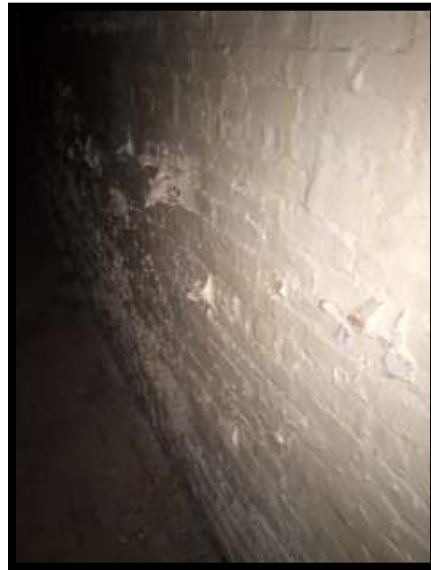
The building is constructed with a masonry perimeter foundation of brick with a few masonry cross walls and a field of wood posts. The foundation walls appear to be in good shape and no signs of significant settling or deflection. The interior walls do show signs of rising damp where moisture wicks up from the ground through the masonry which can cause degradation of mortar joints over time. The wood piers supporting the floor above appear to be in good shape.

*(L) Pooling Water outside basement door (R) Signs of rising damp in basement*

Repairing the roof will remove a significant amount of the water that is currently pooling in the basement. Additional moisture could be removed through the installation of a dehumidification system and site work to make sure the surrounding grade drains water away from the building effectively. The basement stairs on the sixth street side does not drain effectively and this should be addressed in any future work. Any future work that restores the internal downspout system should make sure that the drain lines are sound below grade, as well as in the walls.

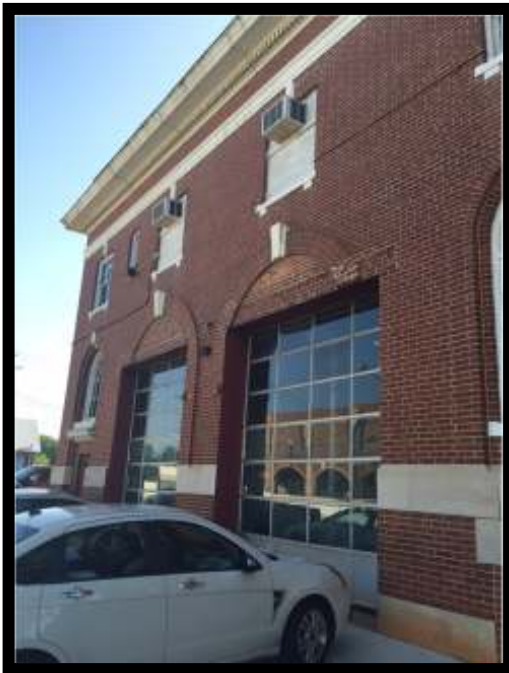
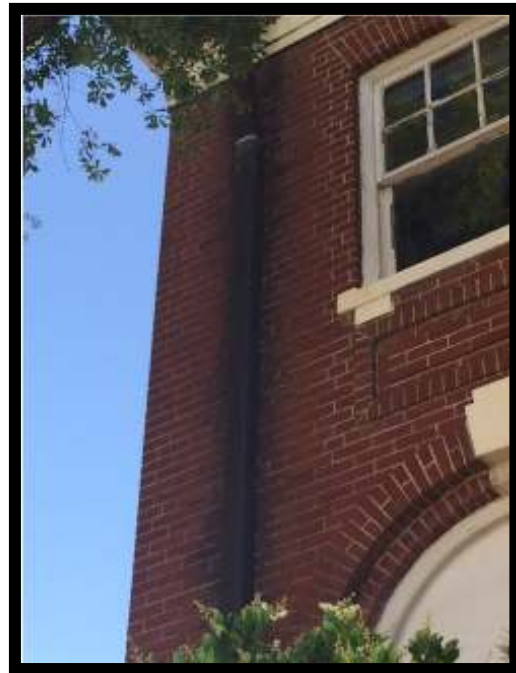
The building is primarily constructed on brick masonry walls in common bond. The two primary facades facing Sixth and Solomon Streets are in a high quality red brick with limestone trim. The secondary facades are constructed of a lesser quality brick of local clay. The brick walls are in good shape for their age but there are signs of erosion where the copper downspouts have over flown and washed the mortar joints away over time and now require re-pointing. Also, two foot portions of the brick walls were removed on the outer edges of the fire bay doors. The limestone belt course in that area was also removed, and the remainder of the lime stone is stained with dirt and biological growth.

*(L) Damage to masonry walls around fire bay doors (R) Signs of overflow eroding brick*

The missing brick and limestone around the fire hall doors should be replaced with in-kind materials that match the color, strength and makeup of the originals, including the mortar materials. The areas where the mortar joints have eroded should be re-pointed using mortar that matches the original in material make up, strength, color, and is the same profile as the original. The entire building should be cleaned low pressure rinses and mild detergent, the limestone should be cleaned using D2 Biologic cleaner per the manufacturers instructions.

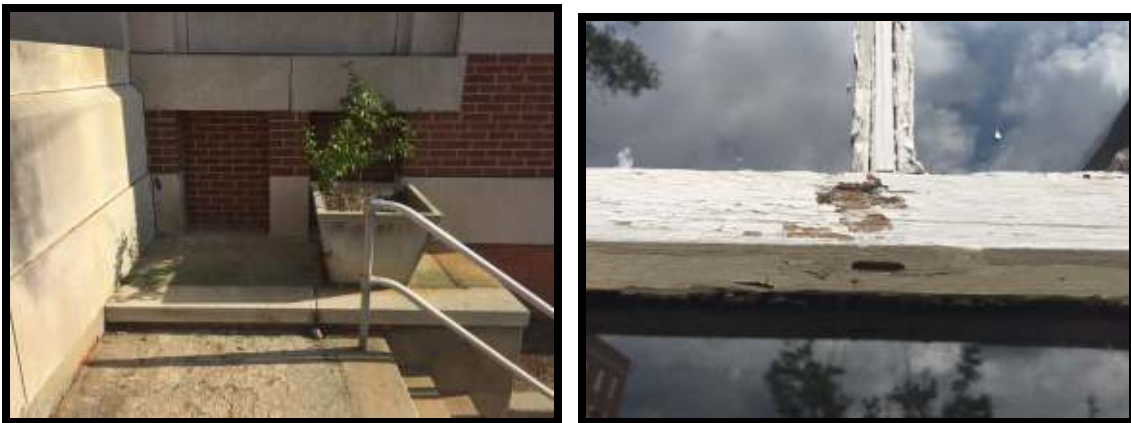
The buildings original wood windows are 8/2 double hung sashes with large half round fan lights that tilt in for ventilation on the front facade and in the court room. The windows have undergone significant water and light degradation over the years and many panes of glass and a few of the lower sash muttons are missing. The basement windows on the front façade have been bricked up and two of the auditorium windows were closed off for the addition of a rear stair tower. The right window in the auditorium has been replaced with an inappropriate replacement and should be returned to its original configuration. None of the existing windows are operable at this time.

*(L) Bricked in basement windows (R) Mortise and tenon construction of original windows*

All of the windows need to be removed and restored by a qualified professional by replacing rotten wood and missing or broken glass with a new pane that matches the original level of waves and imperfections. The old glazing should be removed and replaced with new glazing compound. All of the windows should receive new weather stripping on all edges of each sash and the sash cords should be replaced. Interior storm windows can be added to increase the energy efficiency of the windows if necessary.

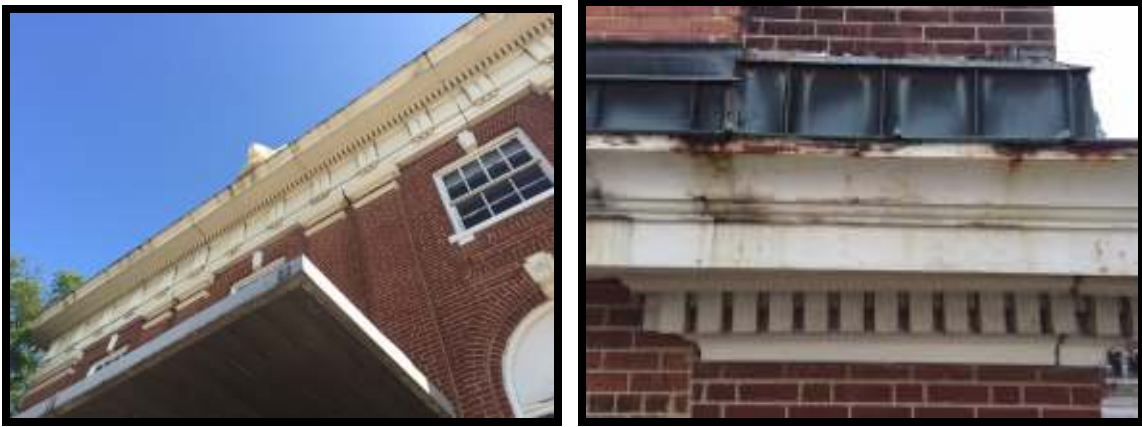
The large cornice on the primary façade of the building is made of stamped metal and then painted to match the limestone. The metal is in remarkable shape for its age, but does show signs of corrosion around fasteners and joints. Additionally, two of the triangular pieces under the triglyphs on the front façade are missing.

*(L) View of cornice sections (R) Metal Cornice showing corrosion and copper top*

The cornice should be stripped of paint using soda blasting after a small test patch is completed to make sure it does not etch the metal. The cornice should then be primed using a good quality corrosion inhibiting primer and then repainted.

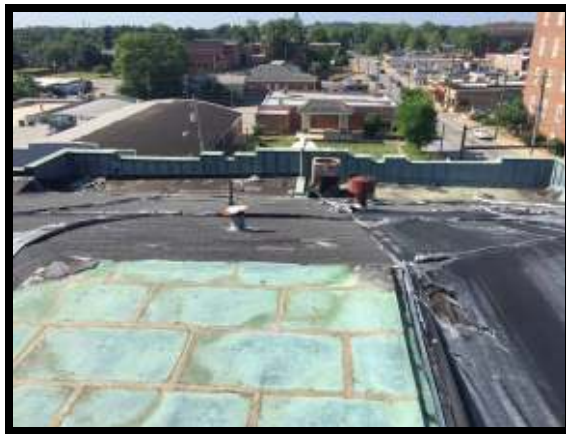
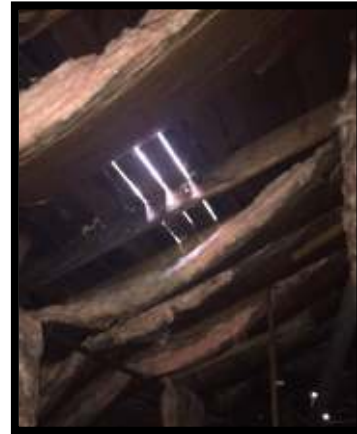
The existing roof is comprised of a parapet wall and concealed gutter with drains, all covered in sheets of soldered copper. The sloped portion of the pyramidal roof is made of 1 inch board sheathing with at least three layers of deteriorated asphalt shingles. The top portion of the roof where the roof access and cupola were located is also flat panels of soldered copper. The asphalt shingles are missing, or significantly degraded, over much of the roof, and the interior downspouts are clogged and leaking. The cupola is now missing from the top of the roof and there are no visible support or anchor points evident.

*(L) Current roof showing copper plates and ruined tarps (R) Signs or roof leak*

The roof is the main cause of the buildings issues and should be the top priority dealt with before any other issue can be addressed. The copper roofing is heavy gauge, and in good shape overall, and should be preserved and restored by a qualified contractor. Any leaking seams should be cleaned and re-soldered in the copper roofing and around the roof drains. The roof drains should be cleaned, and relined with epoxy, and sealed around the drain cover. The existing asphalt roof should be removed and the decking material that is water damaged should be replaced in kind. The roof should be covered in an ice and water membrane and then new faux slate should be installed with a copper half round ridge cap. The cupola should be replaced using exterior grade materials based on the many historic images of the cupola. It should be mounted securely to the roof using noncorrosive anchors and flashing to protect against moisture. If the cupola is to be constructed in a future phase, its construction should be planned from the beginning, and its mounting system should be installed and weatherproofed prior to the installation of the new roof.

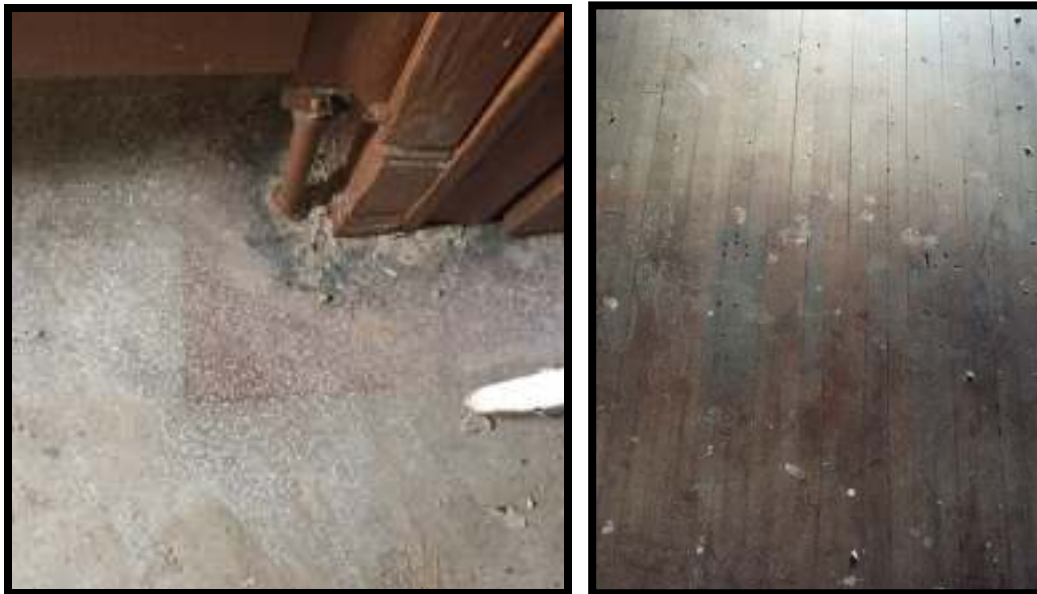
The existing flooring is 1.5 inch strip oak which was popular at the time the building was constructed but is not a standard form today. Much of the original floors are significantly damaged due to roof leaks or covered by glued down vinyl tiles and will need to be replaced. In the Auditorium, the mounting holes and spacing of the original theatre seats are evident, as well as the original floor stain tone. In the foyer and stair hall, the original floors are terrazzo, which is a mixture of cement and marble chips in a white tone with a reddish trim band, which appear to be in good shape.

*(L) Terrazzo floor with border (R) Wood floor showing mounting and wear pattern of seats*

The terrazzo floors can be cleaned with a medium soft scrubber and mild detergent. The spacing of the auditorium seats and the floor stain color should be documented for future replication. The damaged wood flooring should be removed and replaced with new material that matches the original in dimension, milling direction, and species. The floors should then be finished in place using stain that matched the original and a satin varnish.

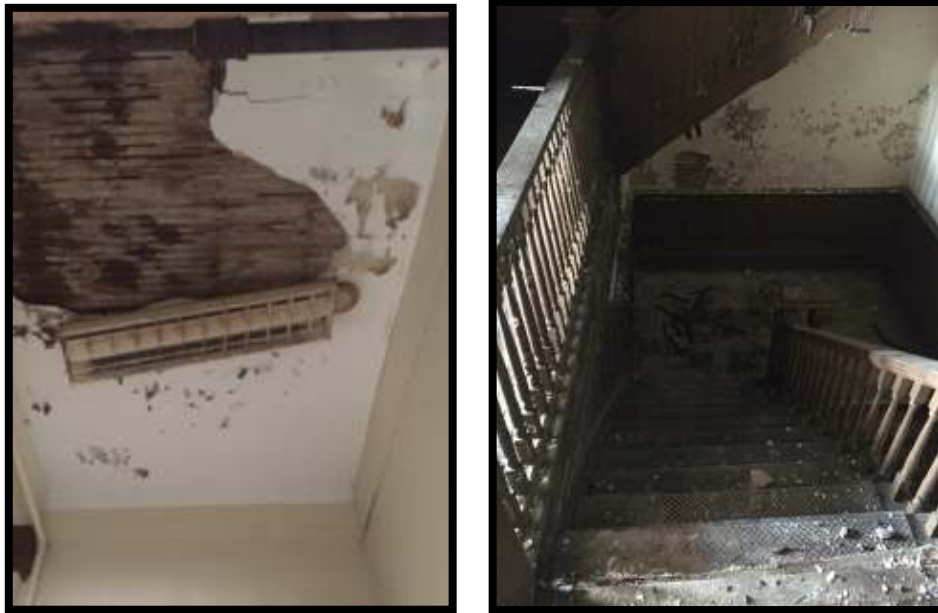
The buildings walls are covered in lime based plaster in a smooth finish. Lime based plaster is superior to gypsum based plaster that became popular in the twentieth century because lime plaster can get wet without degrading, while gypsum will chemically deteriorate. The areas where the plaster has failed are primarily on the ceiling, and are caused by the excess weight of water from the leaking roof, which caused the plaster keys to fail and the plaster to fall. The remainder of the damage is from insensitive alterations like adding duct work and removing transoms. The remaining walls and ceilings have been covered with furring strips and faux wood paneling and dropped ceilings that are not historically appropriate.

*(L) Plaster ceiling damage (R) Water damage to wall plaster paint*

The paneling, furring strips, and dropped ceiling should be removed and patched where necessary. The original plaster should be checked for loose sections that may fall, and any areas identified as unsound should be removed. The remaining plaster needs to be repaired using lime based plaster applied by a qualified contractor. The building needs to be acclimatized for at least six months before the plaster is painted in order for the excess moisture to escape, otherwise, it will force the paint off the plaster.

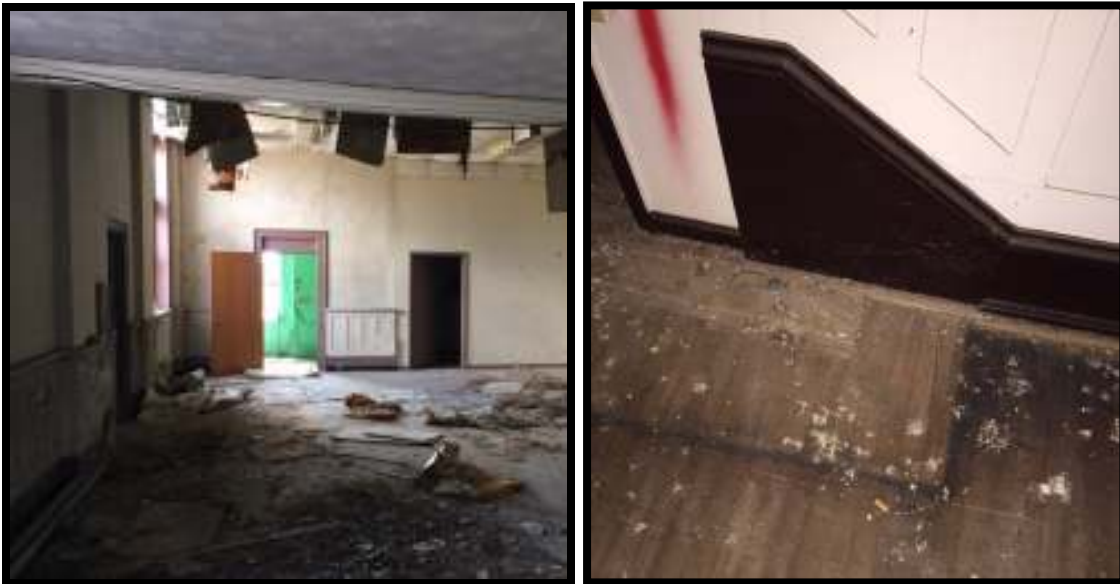
The existing trim is a mixture of oak in the more public areas and pine in the secondary spaces. The building has tall 12 inch baseboards and panelized wainscot in the lobby and auditorium. The door and window casing is slightly more elaborate in the primary spaces and simplified in the secondary with the addition of a chair rail. There are surviving examples of all of the trim in the building, but considerable portions are missing where doors were moved and later paneling was added.

*(L) Trim and Wainscot in Auditorium (R) Outline of missing steps and stage*

The missing trim should be replaced with like materials that match the profile and dimension of the original. The remaining original trim should be stripped to bare wood and all of the trim, new and old, should be refinished based on the original stain and varnish combination.

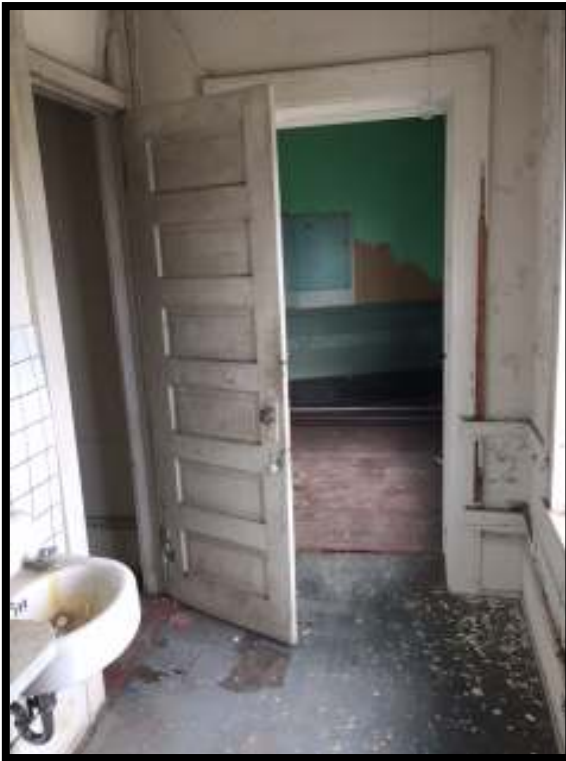
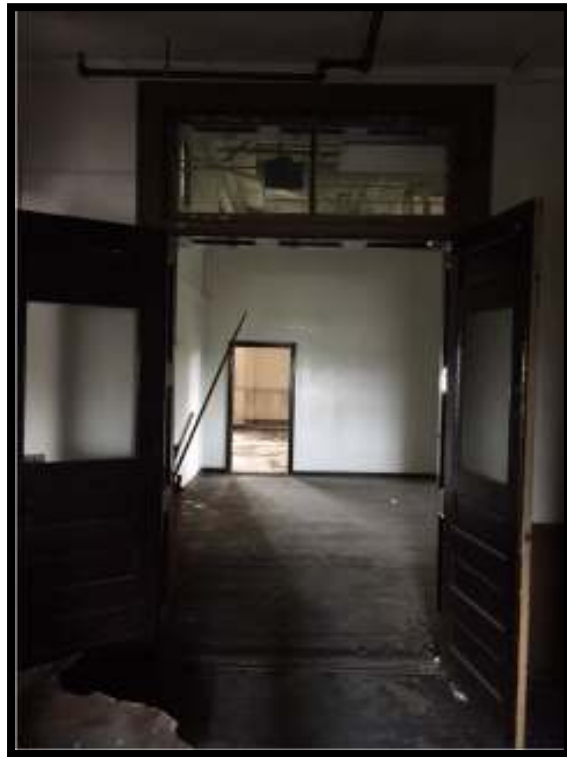
The original doors in the building were 6 horizontal panel oak doors which only survive in a few locations. The remainder of the doors have been replaced with glass or hollow core doors that are incompatible with the buildings historic character. The original doors have brass hinges and handles typical of that era. Many of the doors had operable glass transoms to allow light and air into the center of the building, but most of them have been removed.

*(L) Existing six panel door in bathroom (R) Glazed auditorium doors with transom*

The missing original doors should be replaced with new wood doors that match the originals in design, profile, dimension, and material, including the operable transoms. The surviving original doors should be stripped and refinished to match the original along with the new replacement doors. All of the hardware should be replaced with new unlacquered brass that matches the original in size and profile. The interior set of front doors between the vestibule and lobby should be glazed similar to the auditorium doors on the second floor.

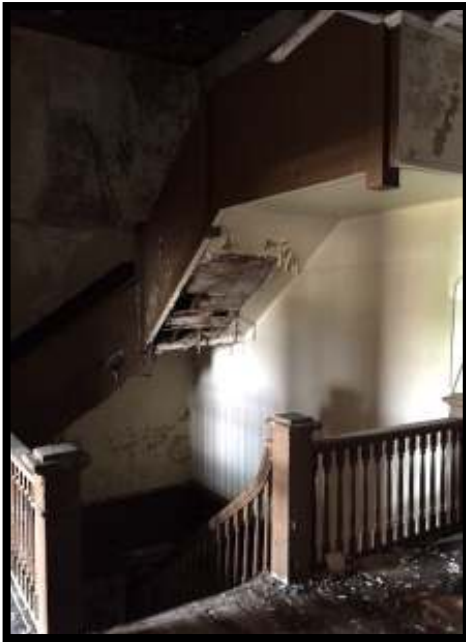
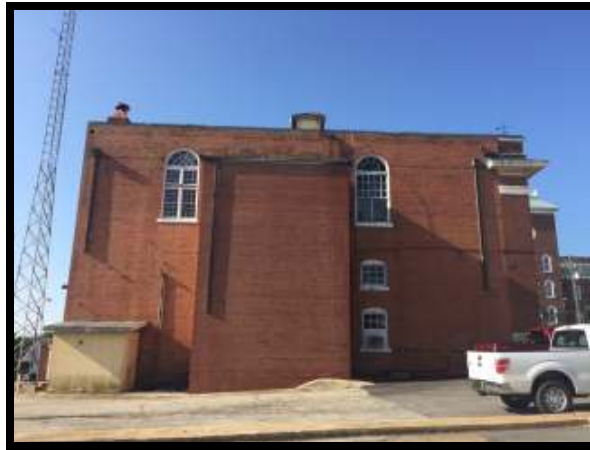
One main staircase with large newel posts, turned balustrades, and heavy rail survives on the left side of the lobby. A twin stair has been removed on the right side and a new floor installed in its place. There is also a stair to the auditorium balcony on the left side of the second floor that has significant water damage. In the rear left corner of the building, there is a metal stair case that has suffered water damage from roof leaks and is too narrow for current fire egress standards. The rear of the building has a large fire escape stair well that detracts from the buildings architectural integrity.

(L) Water damage in surviving stair well (R) Exterior stair well addition in rear

The surviving main stair should be stripped and repaired to be used as a template for the reconstruction of the right stair out of matching materials with identical profiles, scale and layout. The balcony stair should be repaired with new materials where the existing is significantly degraded. The rear corner stair does not meet fire code and should be reconstructed with a 4 foot width. The rear fire escape stair well should be removed and the back wall repaired.

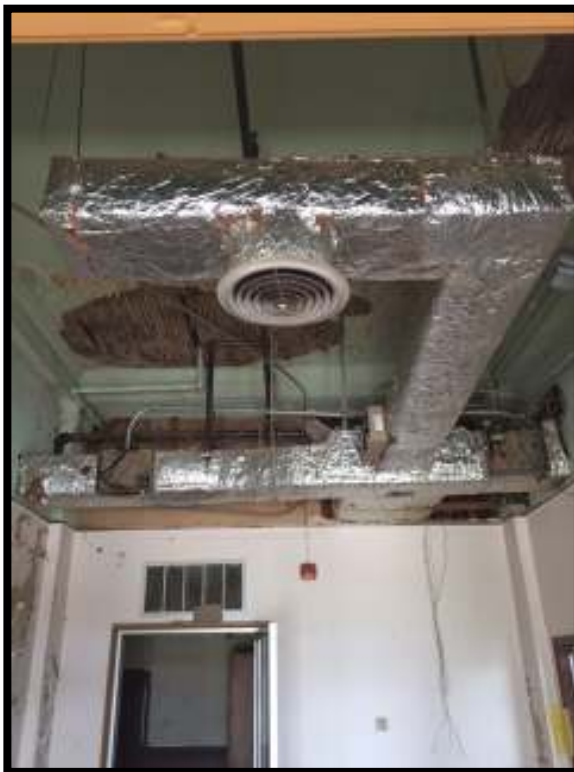
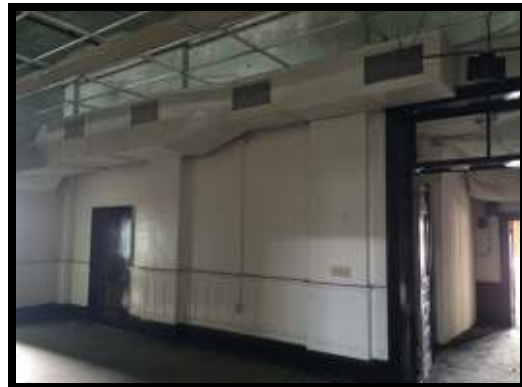
The building was constructed before the use of Air Conditioning, and was originally heated by radiators powered by a boiler in the basement. Over time, the boiler was removed and the windows were sealed shut for the addition of central heat and air. Multiple HVAC units were installed with duct work run through walls and above the dropped ceilings that are now functionally obsolete.

*(L) Duct work added to the lobby (R) Ducts in the Auditorium*

All of the existing mechanical equipment and duct work should be removed and replaced with new high efficiency equipment in the basement and attic where the duct work can be run under the floor or above the ceiling respectively. A high pressure system with a low profile vent opening should be considered in order to limit the visual impact.

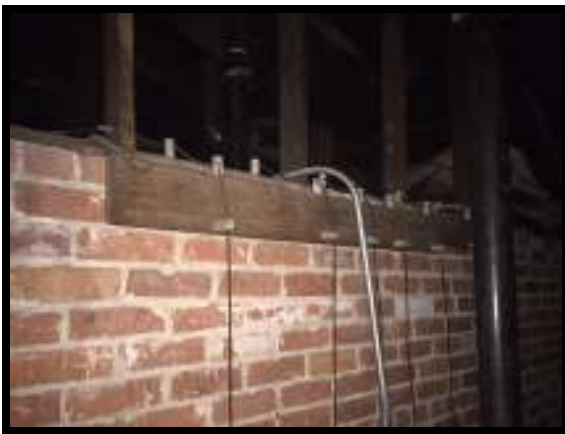
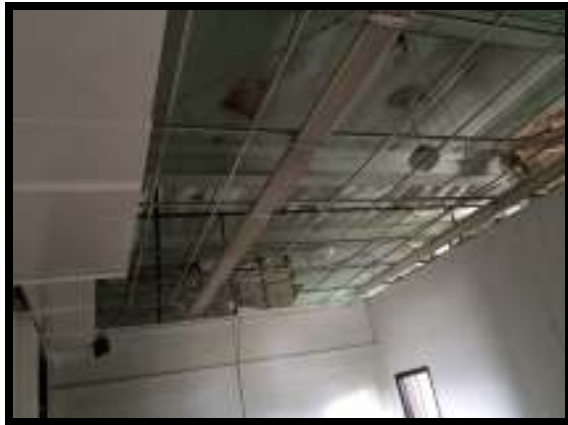
The current electrical system appears to be a combination of new wiring and original knob and tube. This system is dangerous and has a significant risk of fire.

*(L) Knob and tube wiring in attic (R) Non-original light fixture in auditorium*

The existing electrical service should be replaced completely with new service that meets current code. The current fixtures in the building are not historically accurate and should be replaced with modern electrical fixtures that are appropriate to the era. These include push button switches and three tiers of lighting; Beaux Arts pendants in the public spaces, school house pendants in the office spaces, and period industrial fixtures in the fire hall areas.

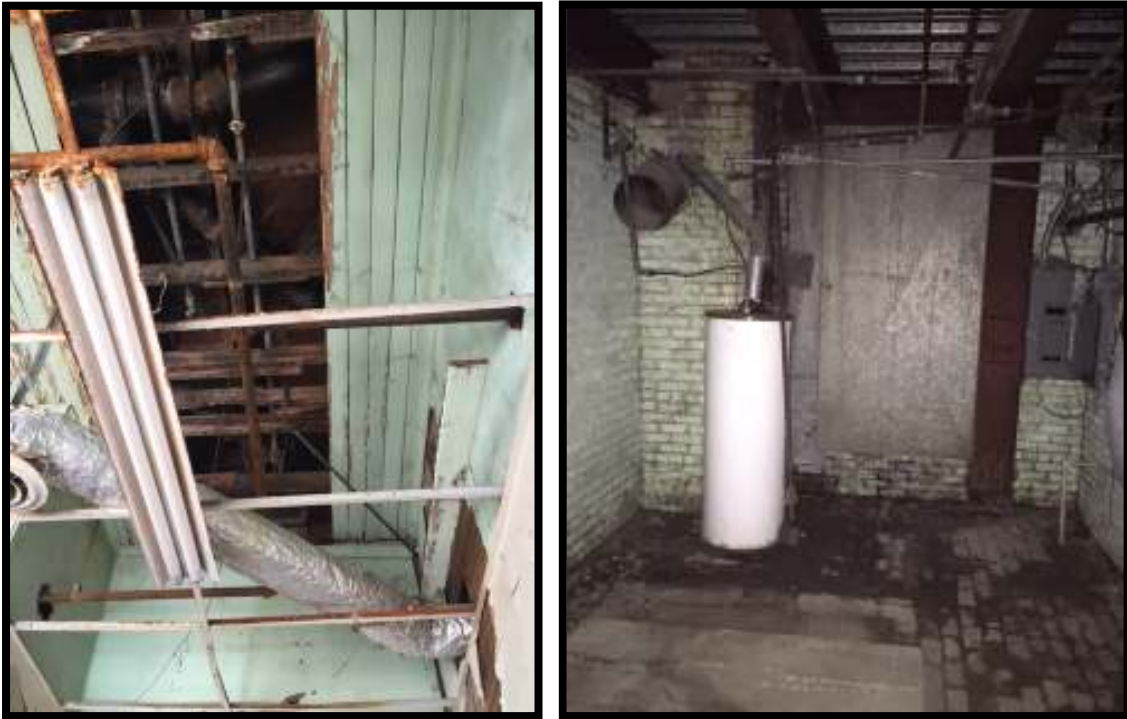
The buildings cast iron plumbing has not been used in many years and may not hold pressure at this point. Many of the current plumbing locations are not conducive to the future use of the building.

*(L) Original plumbing with signs of corrosion (R) Missing boiler in basement*

The plumbing system should be assessed by a qualified plumbing contractor and the lines reoriented to new plumbing locations, based on future rehabilitation plans. Original plumbing fixtures in good shape should be salvaged and restored where possible.

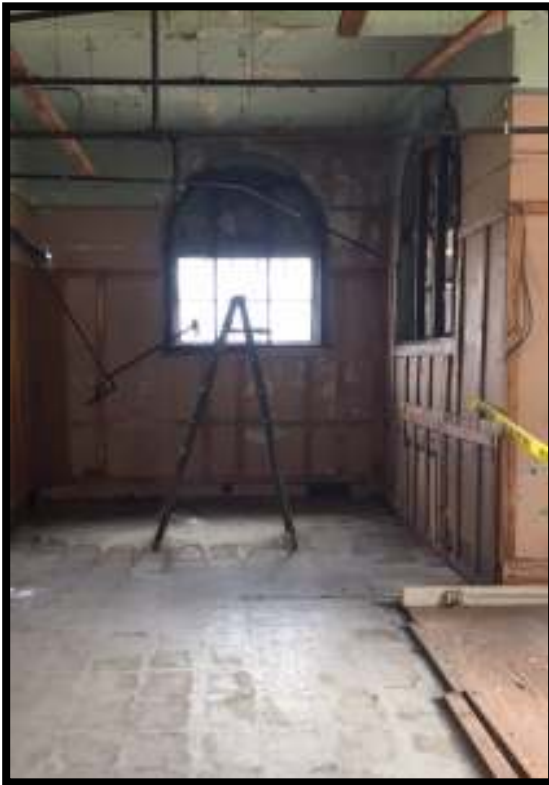
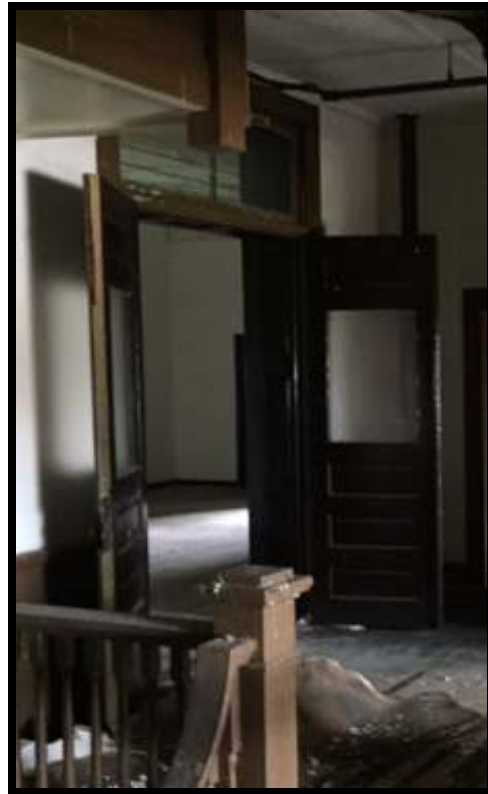
The building currently has a fire suppression system on all floors and the attic with the main stack located in the lobby. The system has not been flushed in many years and the heads should be checked before it is pressurized again. The system was also installed in conjunction with the installation of the dropped ceiling which required heads oriented down and up below the original ceiling.

*(L) Sprinkler pipes in first floor ceiling (R) Stand pipe in foyer behind door*

The fire suppression system is an asset to the building and should be maintained and restored in a future rehabilitation. The system can be left intact in the attic, but should be reconfigured on the remaining floors to place the pipes behind the plaster and the heads recessed in the ceiling with a cover. The main stand pipe should be relocated out of the lobby and into a more discrete location.
